# The Effectiveness of Vertebrate Passage and Prevention Structures: A Study of Boeckman Road in Wilsonville

# **The Effectiveness of Vertebrate Passage and Prevention Structures: A Study of Boeckman Road in Wilsonville**

**OTREC-RR-10-14  
September 2010**

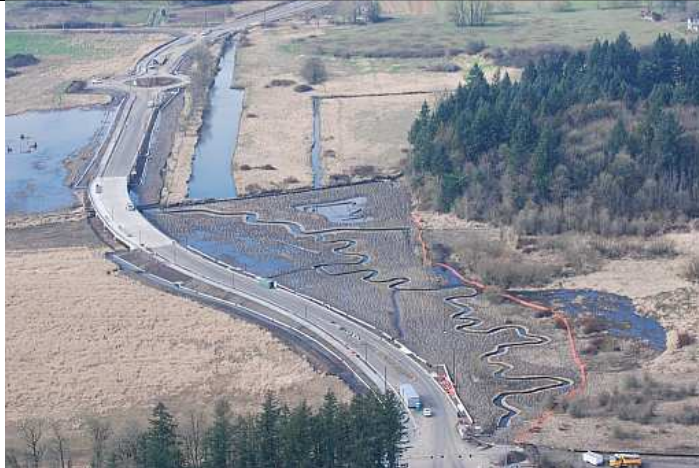
Figure 2.1.2: Aerial photo of Boeckman site during construction. Photo was taken from the east looking west. Research was primarily conducted in the northeastern area of the project (lower right quadrant of photo).

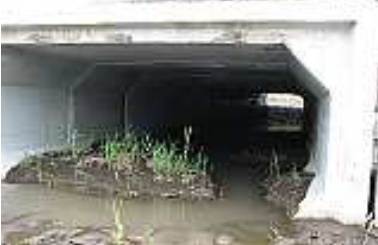
Figure 2.1.5: 9-foot span by 4-foot rise box culvert.	Figure 2.1.6: 24-inch-round concrete culvert.	Figure 2.1.7: Bridge and Boeckman Road looking east.

Both 9 by 4 culverts and three of the four 24-inch culverts include grating that allows natural light penetration. In addition to incorporating wildlife passage and prevention structures, the project required restoration and enhancement of the wetland. This enhancement included adding meanders to what had been a straight drainage ditch and planting, in 2008, willows and other vegetation.

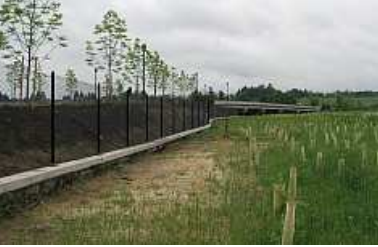
Figure 2.1.8: Chain link mammal fence (6 feet) atop the amphibian/reptile wall (2 feet). Note bridge in background.	Figure 2.1.9: 18-inch-round concrete culvert. Note amphibian/reptile wall with overhanging lip.	Figure 2.1.10: Photo taken from under the bridge passage.

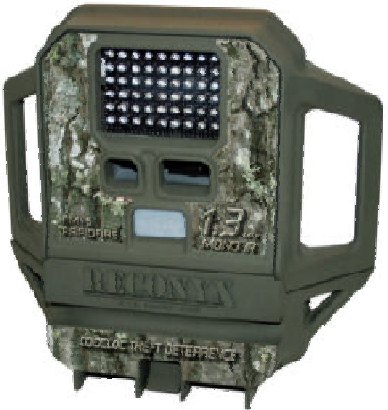
Figure 2.2.1: Reconyx brand motion-detection camera used to monitor wildlife movements.	Figure 2.2.2: Segment of sand-track pad under bridge section 3.

In order to monitor passage use, a combination of sand-track monitoring and motion-detection cameras was used (Figure 2.2.1 and 2.2.2). Sand-track monitoring was conducted on a weekly basis from May to September 2009 under bridge sections 2 and 3 to account for small animals not likely to be captured by the cameras. Similar tracking was conducted in 2008 as well, but is not reported here due to the temporal mismatch with the camera data.

Reconyx brand model RM45 motion-detection, infrared cameras were used to identify vertebrate species using the passage structures as well as to compare passage use to movement across the landscape. Each camera in the surrounding habitat was mounted on a metal fence post, approximately one-third to one-half meter from the ground surface, with a slight angle downward to limit false triggering. Cameras in small passage structures (18-inch and 24-inch) were mounted directly to the concrete and were similarly angled but positioned more closely to the ground (approximately 15cm). The cameras in these culverts therefore were effective at detecting movement of small animals. Cameras located under the bridge were mounted to posts and angled only slightly downward to capture medium and large animals moving across the entire span. As a consequence, cameras under the bridge were much less capable of capturing small animals such as mice, voles, snakes and frogs. To supplement the bridge camera data, sand-track pads were established under bridge sections 2 and 3 and were monitored weekly. Camera flash cards were exchanged and batteries checked on a weekly basis. Collected cards were brought back to the lab and downloaded. Species were then identified and entered into an Access database. Animals' ability to traverse and the presence of standing water near passage structures were assessed and documented on 31 Aug. 2009.

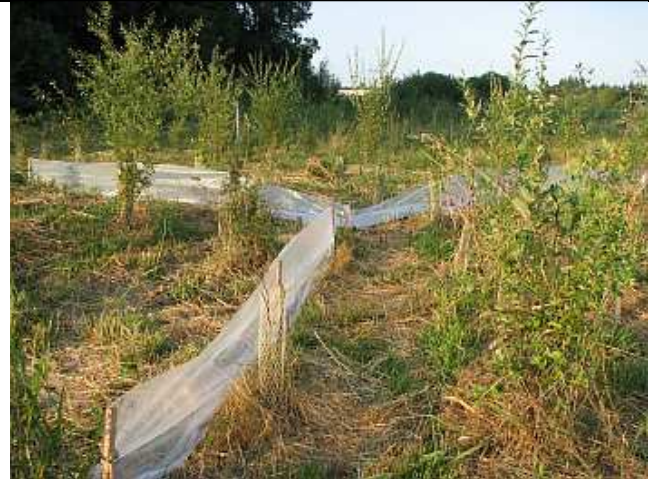
Figure 2.2.4: 100M North Station 1 pit trap array. One bucket is located in the center of the array of plastic sheeting.

Detection of small animal movement was limited with camera monitoring in the surrounding habitat because the angle and proximity to the ground necessary for the cameras to capture small animals would severely limit the range and ability to detect large and medium animal movements. In order to compensate for this shortcoming in camera data on small organisms, we also conducted tag-and-release studies targeted to small mammals. Trapping methods included pit traps (Figure 2.2.4) and Sherman traps (3"x 3.5"x 9" folding aluminum). One of each type of trap was deployed per station for the 100M North, 25M North, 2M North and 2M South transects, for a total of 72 traps. Traps were deployed for three consecutive nights per month during late summer 2009 (31July-2 August, 25-27August, and 21-23September). Traps were baited and opened at dusk, checked at dawn during trapping sessions, and then closed for the day. Voles and mice were tagged using metal ear bands (Figure 2.2.5) with unique identifying numbers, while shrews were released due to their lack of pinnae, which are required for placement of ear tags.

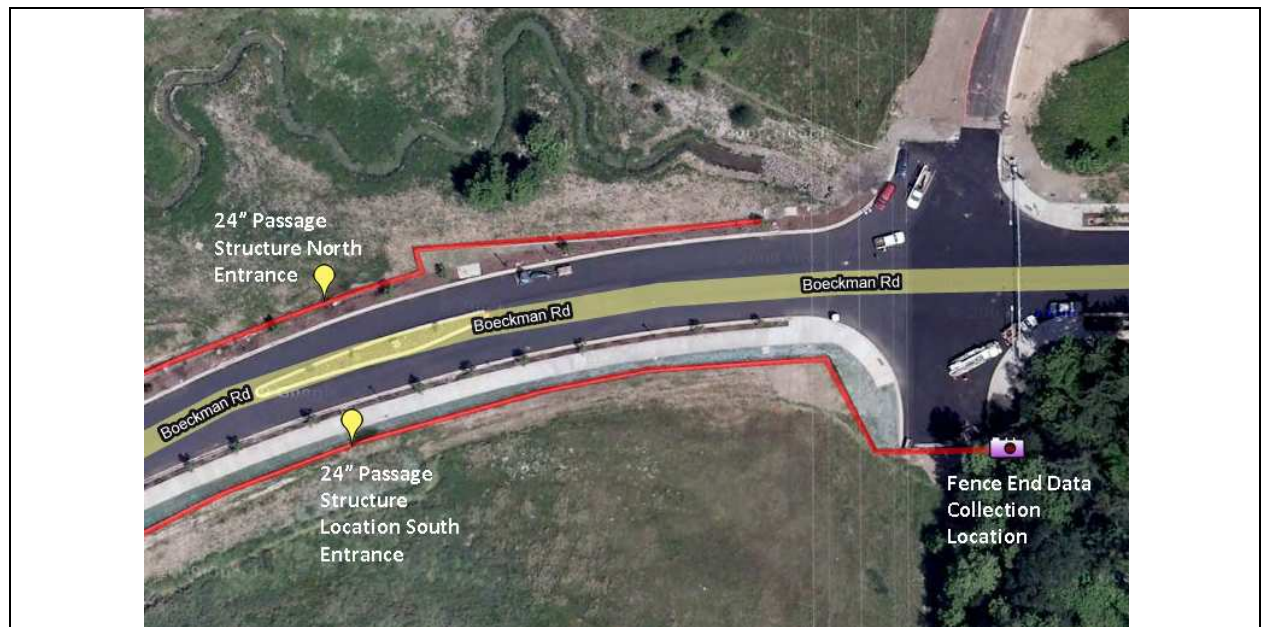
Figure 2.2.6: Fence end monitoring location in relation to fence end (red lines) and nearest passage (24-inch-round concrete culvert).

Camera data collected in passage structures were compared to camera monitoring at the end of the exclusionary fencing (Figure 2.2.6). The direction animals were traveling was noted in order to best determine if the animal was about to, or had just, crossed the road surface.
